## **Stormwater Infiltration in Clay Soils**

**A case study in the North Carolina Piedmont**

*by Christopher J. Estes*

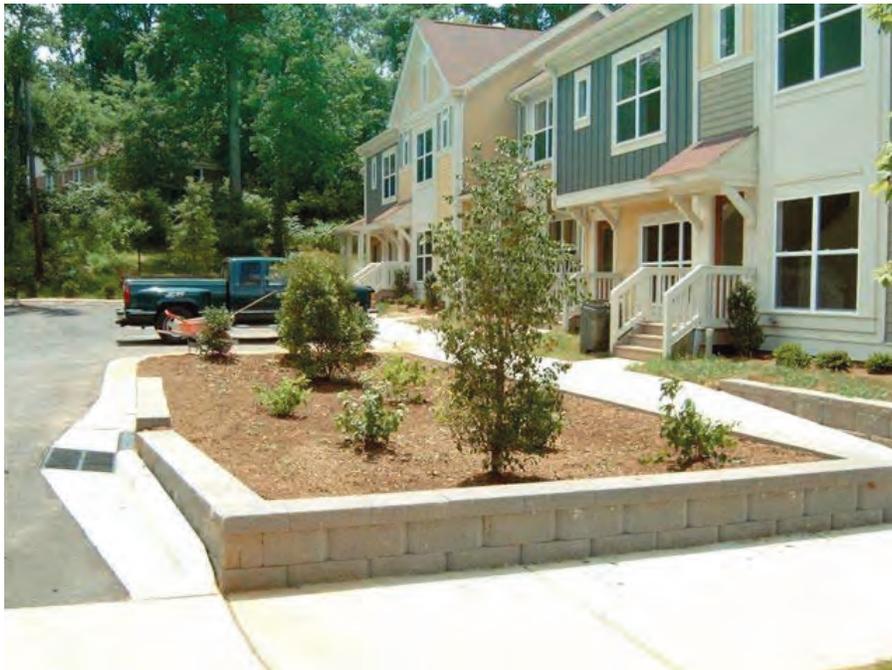
**Figure 1. A bio-retention garden at Wilmore Walk**

The bio-retention areas were incorporated to fit a very tight site design, and are almost indistinguishable from typical landscaped areas.

As required by the regulatory authorities at the time, the bio-retention gardens all have subdrains that connect to the conventional storm water drainage infrastructure and have minimal infiltration function. It is important to note that although these bio-retention gardens do not infiltrate to their maximum capacity they can be easily retrofitted to do so.

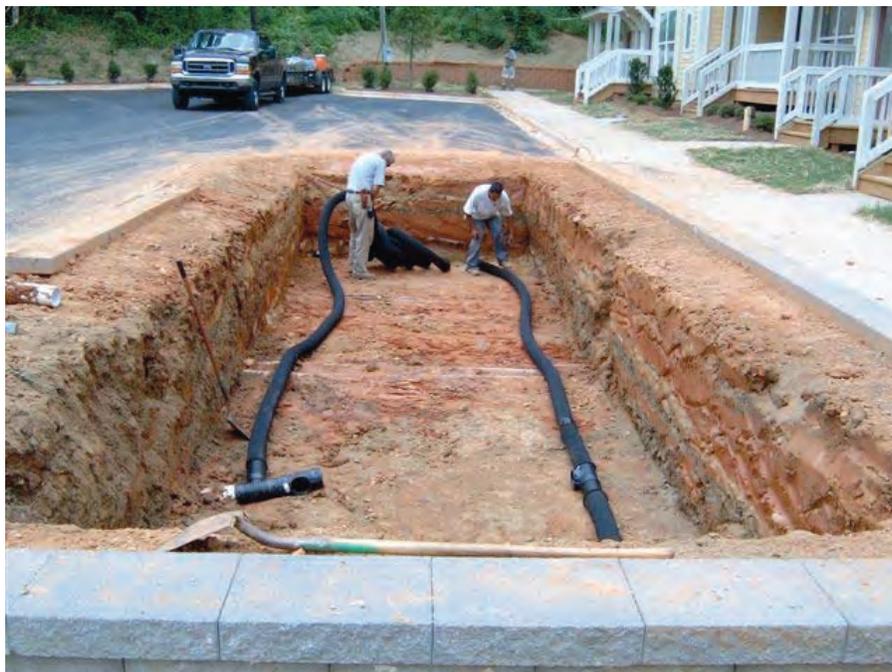
**Figure 2. Installation of a bio-retention sub-drain system, Wilmore Walk**

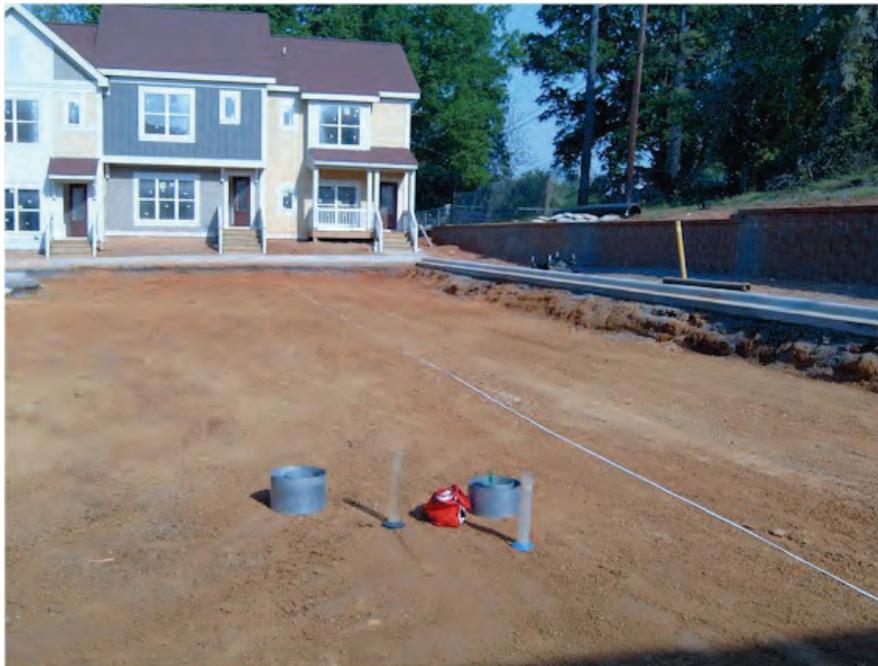
**Figure 3. Native soil infiltration rate testing at Wilmore Walk.**

Pre-construction infiltration testing was conducted for the proposed pervious concrete parking lot, utilizing a double ring infiltrometer. Test results yielded a range of 0.23-3.1 in/hr with an average infiltration rate of 0.90 in/hr for the existing unmodified sandy clay subgrade. The lowest rate of 0.23 in/hr was measured in an area of light compaction caused by a bobcat with rubber tracks. The highest infiltration rate, 3.1 in/hr, was measured in an area that was cut raked, with no compaction.

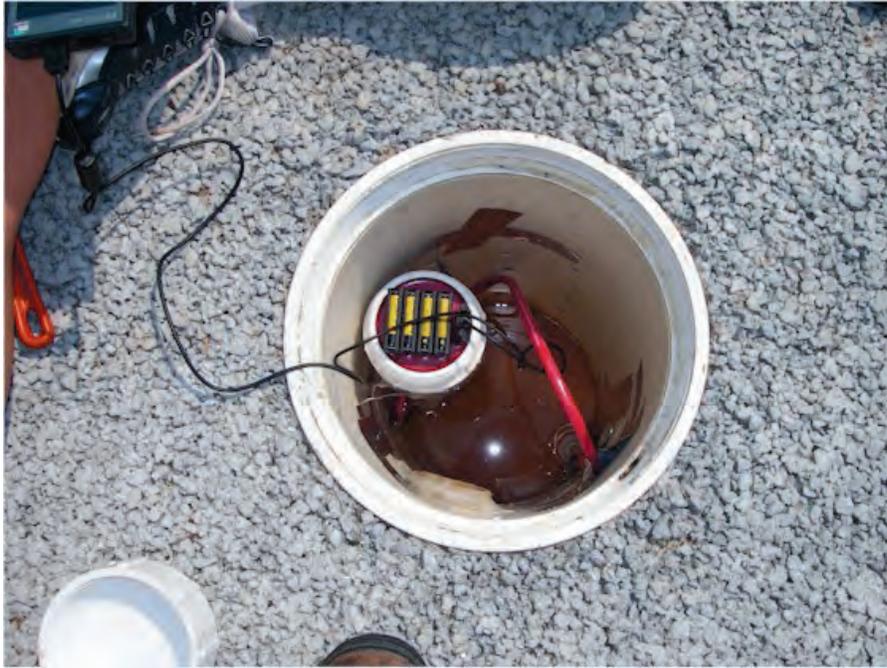
**Figure 4. Monitoring well in porous concrete parking lot**

Six inches (6 in) of pervious concrete can detain and store 1.5 in of rainfall. A reservoir base course composed of single-size aggregate with approximately 30-40% voids and underlain with non-woven filter fabric was added to the design to retain the 2-year recurrence storm event for the parking lot and adjacent roof top drainage area. The base reservoir was excavated into existing soil as a closed basin; there is no primary drainage outlet except infiltration into the soil. The base's aggregate material was placed on the soil without further compaction. For post construction monitoring purposes, three PVC monitoring wells were incorporated to house water level data loggers.

Post construction infiltration monitoring data was collected using an Infinetes USA pressure water level data logger. The monitoring period was one year. The data presented here was for a six-month period from August 2006 through February of 2007.

During the post-construction monitoring period, several months of data had to be disregarded due to malfunction of the pressure sensor. The problem was apparently due to sediment that was present in an installed conduit directly above the sensor. However, results of the monitoring data from August through September 2006 included eleven rain events, five of which ranged from .98 in to 2.97 in per day. The maximum rate that the reservoir raised during any single event was 3.4 in/hr ( $\pm 1$  inch water level equivalent). The reservoir water level reflects the available void space in the stone and additional catchments surrounding the porous concrete lot. Infiltration rates into the existing subgrade varied, depending on the depth or head of the water in the reservoir, which is consistent with Darcy's Law.

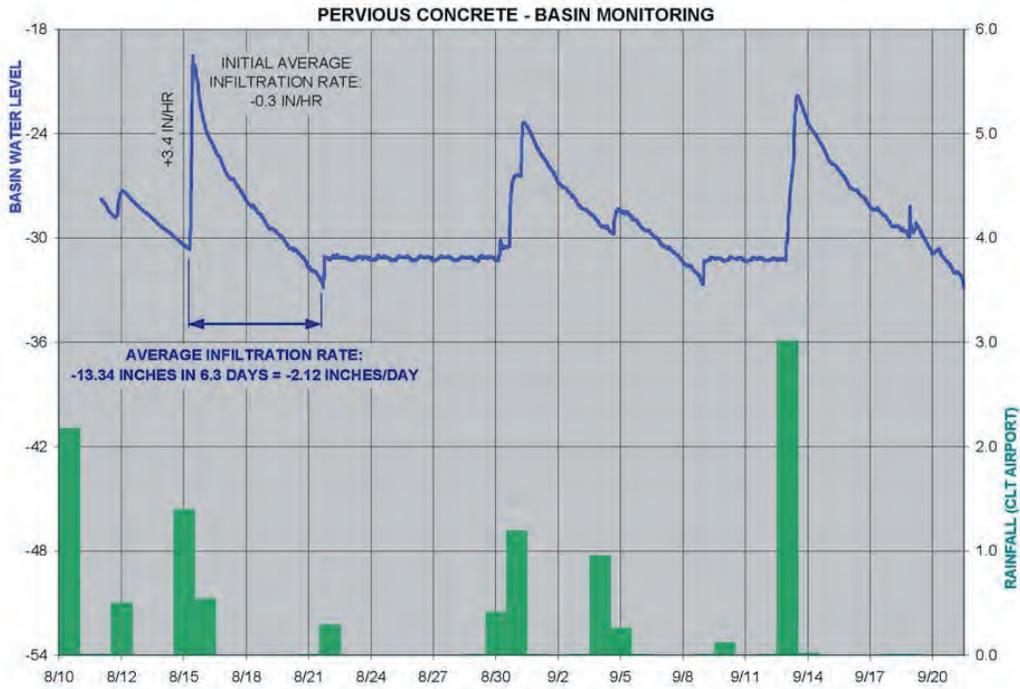
Figure 5. Wilmore Walk Reservoir Monitoring Data for rain events August - September 2006

The maximum recorded water depth within the reservoir was 13.28 inches ( $\pm 4$  inches water equivalent). During this event, the soil infiltration rate at maximum head was 0.29 in/hr. During the following 6.3 day period between storm events, the water level in the reservoir dropped 13.24 inches. As the water level declined with time, the infiltration rate also declined, which is consistent with the role of head in Darcy's law. The average rate of infiltration was 0.09 in/hr, or 2.1 in/day. During the majority of the recorded events, infiltration was occurring in saturated soil conditions.

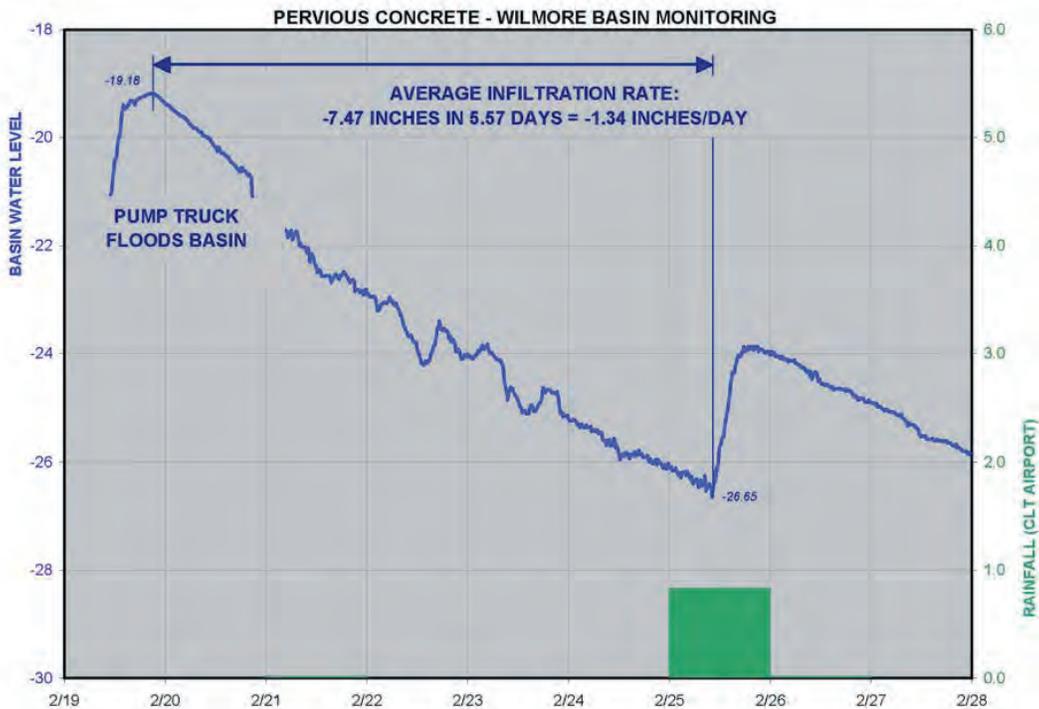
Figure 6. Wilmore Walk Reservoir Monitoring Data of filling by watering truck

In February 2007 the reservoir was artificially filled utilizing a water truck. Prior to filling the reservoir, the water level was measured at 2.28 in ( $\pm 0.7''$  water equivalent). The final water level depth after filling was 13.74 in. From the time the reservoir was artificially filled and the next rain event 5.57 days later, the average infiltration rate into the subgrade was 0.06 in/hr, or 1.34 in/day, with a total water level drop of 7.42 inches.

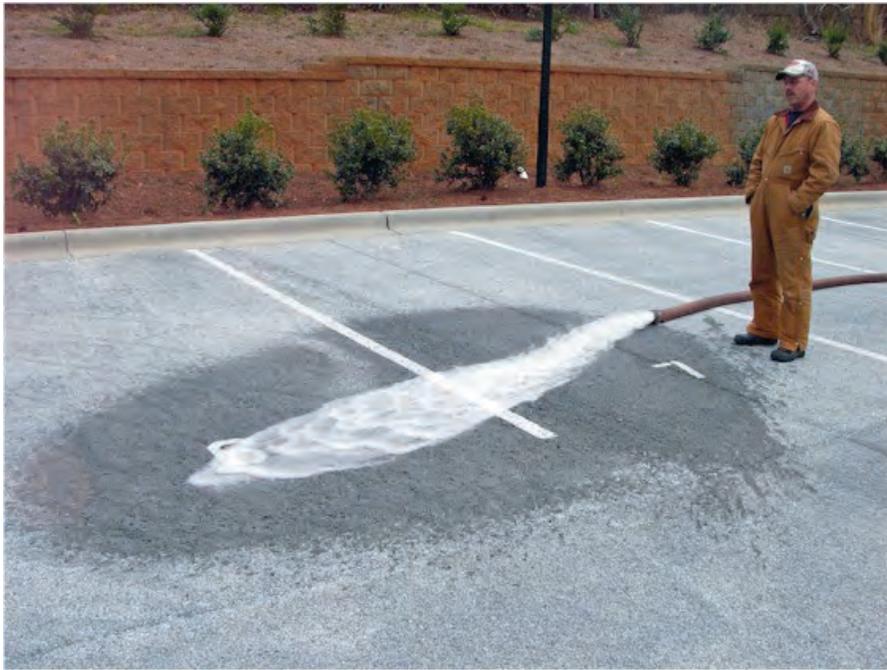
**Figure 7. Wilmore Walk Reservoir filling by watering truck.**

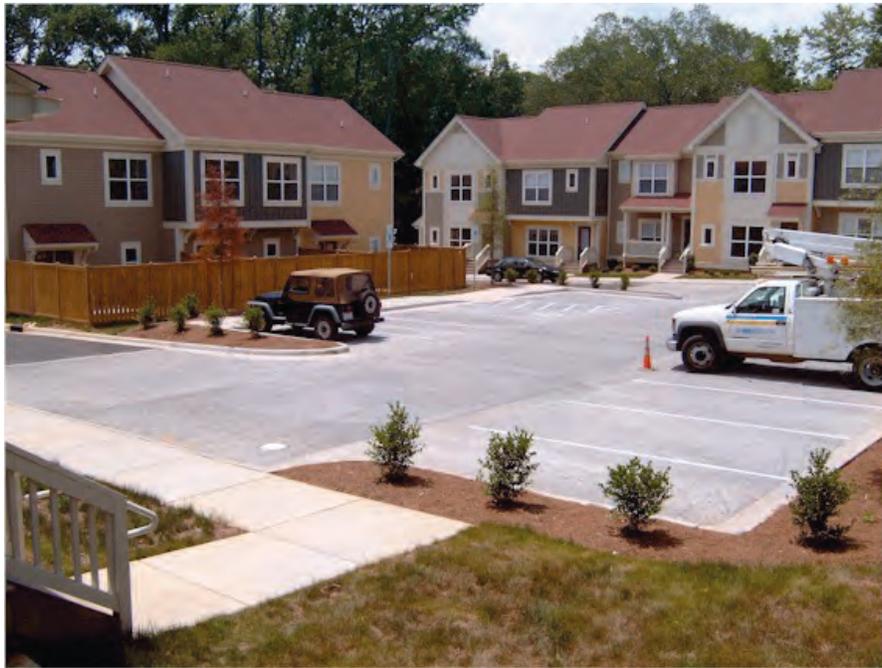
**Figure 8. Wilmore Walk finished porous concrete parking lot**

Pervious concrete was chosen as the material for the porous parking lot due to its high infiltration rate and for its durability and ease of maintenance. The infiltration efficiency of pervious concrete depends on the consistency of the mix and installation quality, but typically exceeds that of other manufactured paving systems. Properly installed pervious concrete contains 15%-30% void space throughout the entire volume of the application. The voids increase in size from top to bottom of its cross section, greatly reducing the chance of clogging. Flow rates through pervious concrete range from 140 to over 1,000 in/hr.

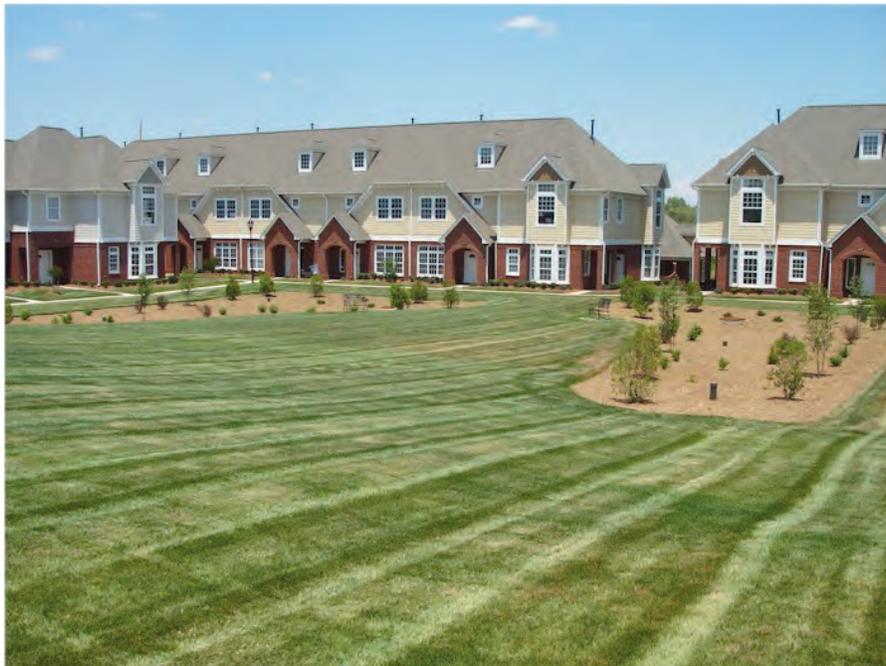
**Figure 9. Jetton St. bio-retention gardens**

This project incorporates three bio-retention gardens with sub-drains and two bio-infiltration gardens that rely entirely on exfiltration into the native soil for drainage. The two bio-infiltration gardens are designed to retain and infiltrate the 2-yr recurrence design volume (3.12" per the Charlotte-Mecklenburg Storm Water Design Manual). Two other bio-retention gardens with subdrains detain the 2-yr recurrence design storm. A remaining bio-retention garden is the smallest and is designed to detain the 1" storm event, which is then routed to the first bio-infiltration garden.

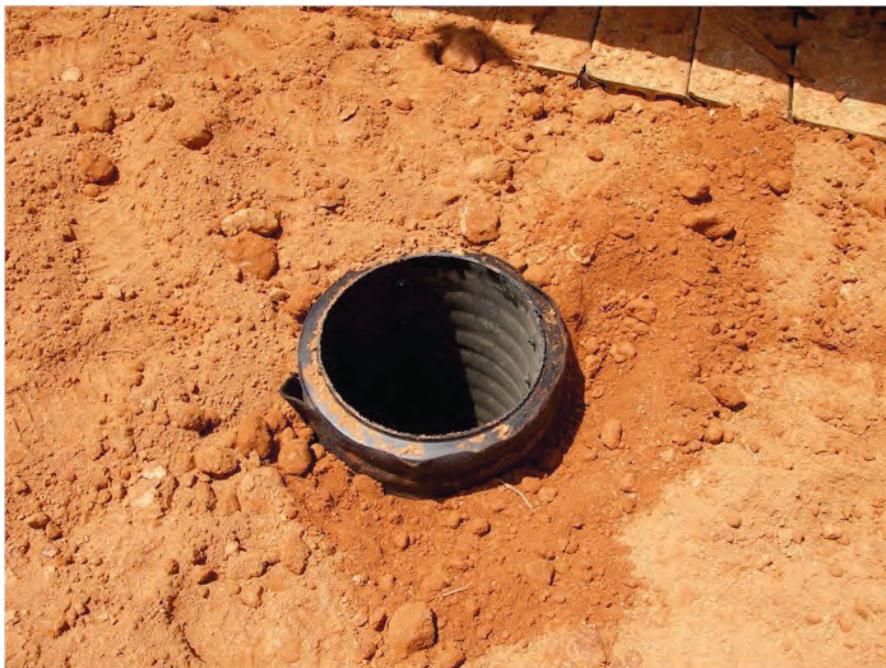
**Figure 10 Jetton St. 15" diameter monitoring well**

The monitoring devices for this project site differ from the previous Wilmore Walk project site in that the monitoring devices are capacitance water level probes placed in 6.5 foot deep wells that extend from the surface of the installed soil mix to approximately 1.5 feet to 3.3 feet below the bottom of the constructed infiltration gardens. These monitoring wells are perforated pipe and also act as infiltration wells.

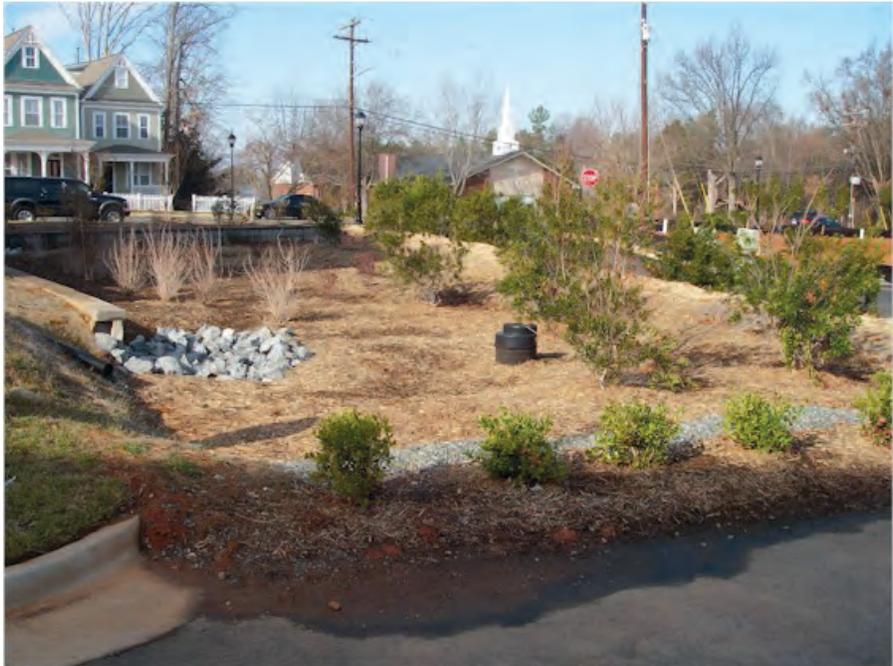
Figure 11. Jetton St. Bio-infiltration Garden

For infiltration garden 2, noted as “infiltration pond” on the data sheets, the maximum rate the reservoir water level rose during the period was 5.6 in/hr. The maximum water level measured in the field during this period was 111 inches (33 inches above the top of the well). Again, consistent with Darcy’s Law, infiltration rates through the installed soil mix varied with depth or head of the water from 0.15 to 0.31 in/hr. A consistent and distinct rate increase was recorded once the water level reached native soils below the geotextile fabric. This is visually apparent in Figure 11.

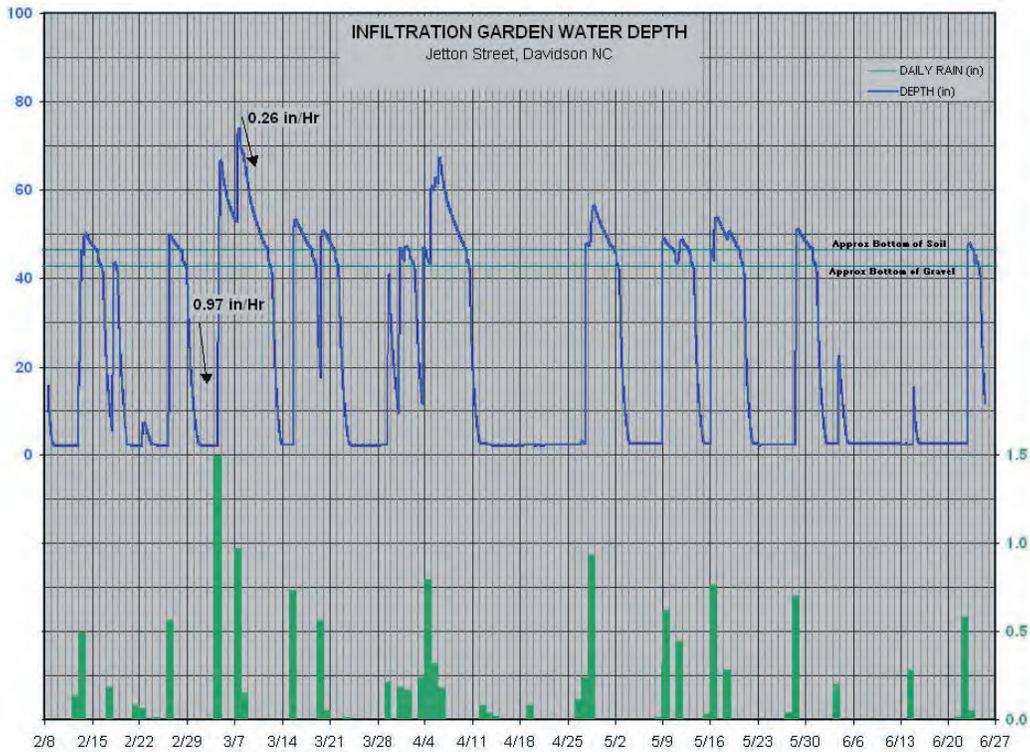
Figure 12. Jetton St. Bio-infiltration Garden monitoring data

For infiltration garden 1, the maximum rate the well water level rose during this period was 46.24 in/hr ( $\pm 15$  in/hr water equivalent?). The maximum water level recorded during this period was 74.06 inches above the bottom of the well. Consistent with Darcy's Law, infiltration rates through the installed soil mix varied with depth or head of the water. Once the water level infiltrated past the bottom of the installed soil mix and filter fabric the infiltration rate increased by a factor of 3.7. The average rate increased from 0.26 in/hr through the installed soil mix to 0.97 in/hr into the native soil matrix.

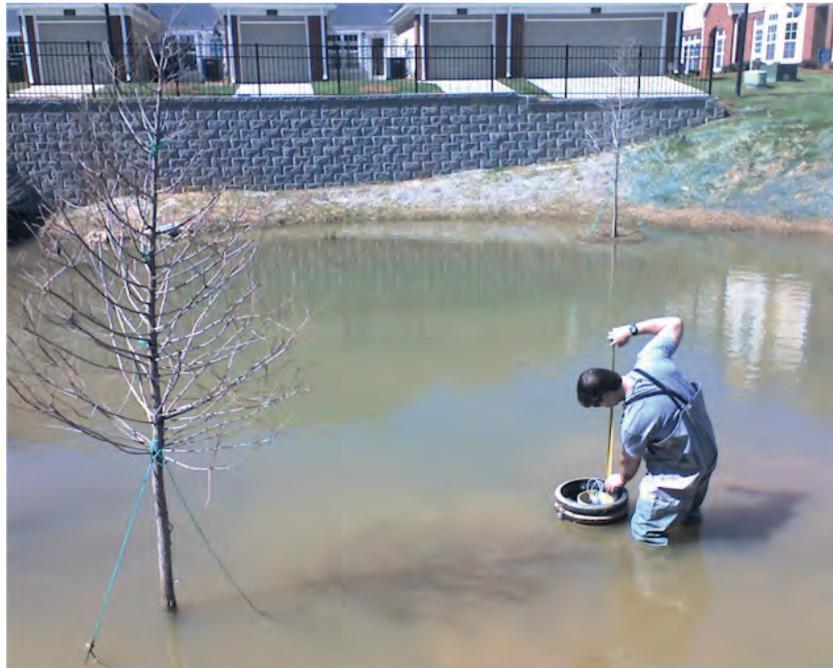
**Figure 13. Jetton St. Bio-infiltration Garden 2 (infiltration pond)**

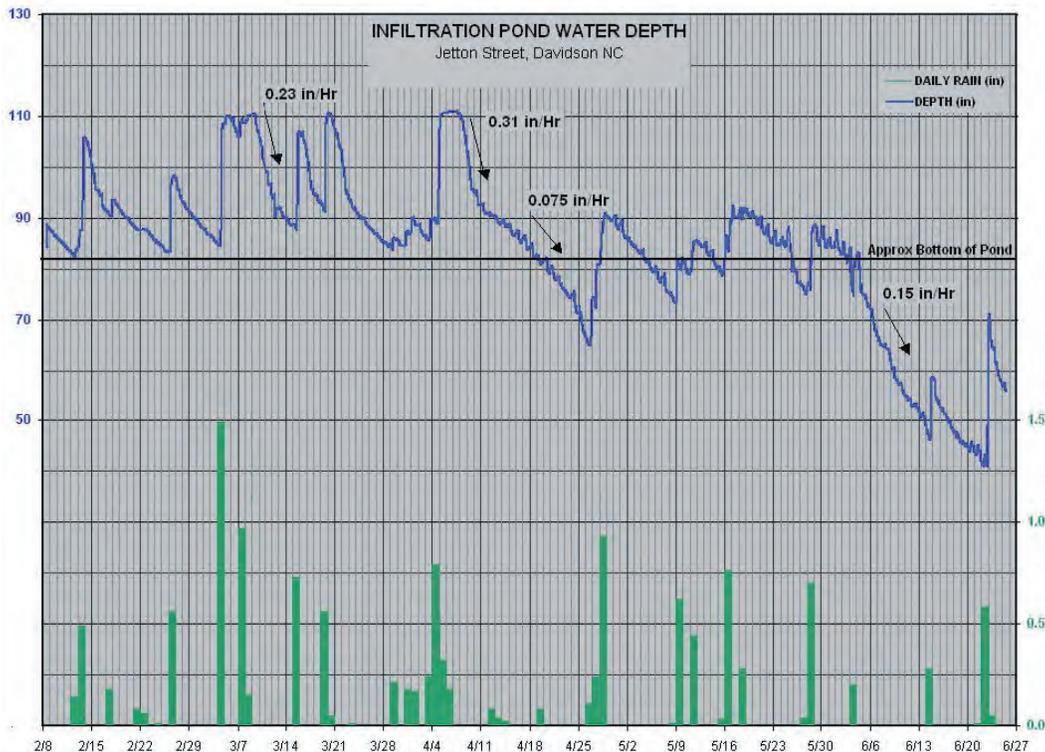
**Figure 14. Jetton St. Bio-infiltration Garden 2 monitoring data.**

The reasons for variation in infiltration rates between the infiltration gardens may be the elevation differences affecting proximity to the existing water table and the introduction of irrigation run off. Infiltration garden 2 is lower in elevation and maintains a shallow vadose zone. Irrigation water is introduced to infiltration garden 2 through the storm system.

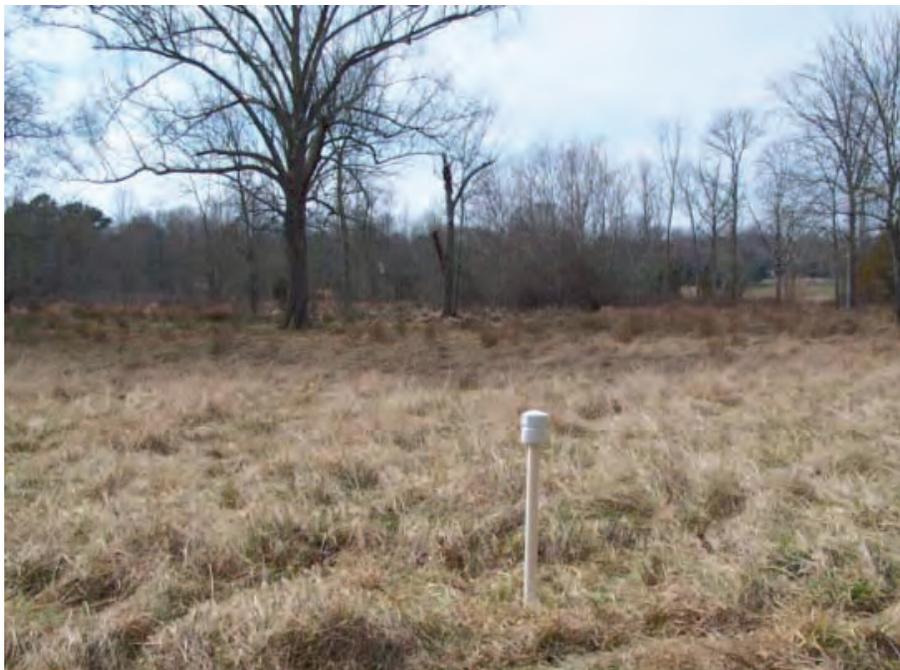
**Figure 15. Sixmile Creek Site monitoring well.**

The monitoring period was from March 2006 to March 2007. Two Infinetes USA pressure water level data loggers were installed 41.5" below the ground surface to document the existing hydrology prior to restoration activities. The monitoring data was compared to rainfall data to gage infiltration rates into the existing subgrade.

The measured infiltration rates ranged from 0.354 in to 0.439 in, with an average infiltration rate of 0.42 in/hr.
